Intervention Saint Paul

OP3-25 – Nivmer

Intervention le 17/11/2025 entre 06h14 et 09h25 (heure UTC+5)

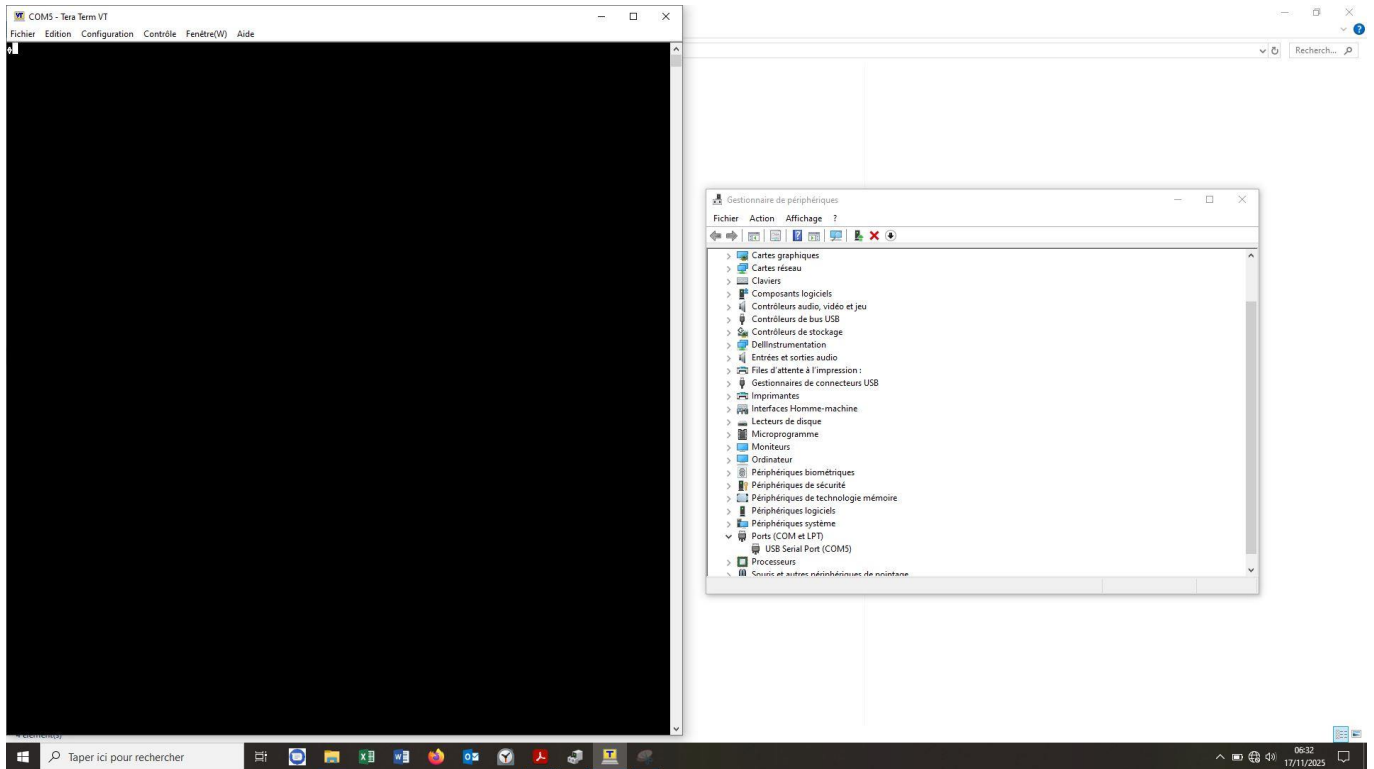
Test de la communication :

Les tests en tapant sur entrée et les plusieurs ctrl+k → pas de réponse

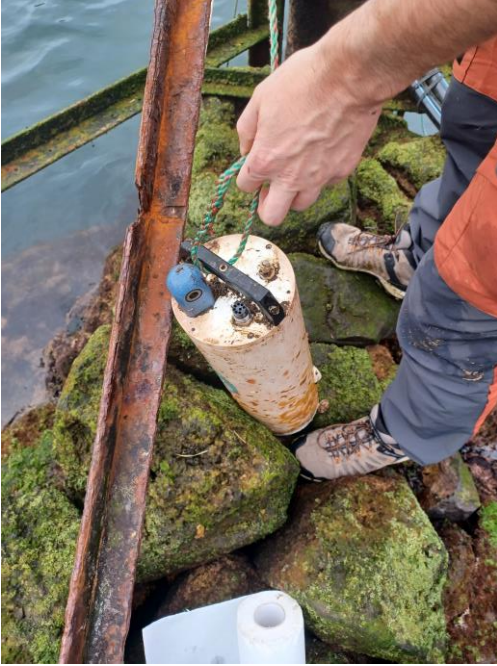
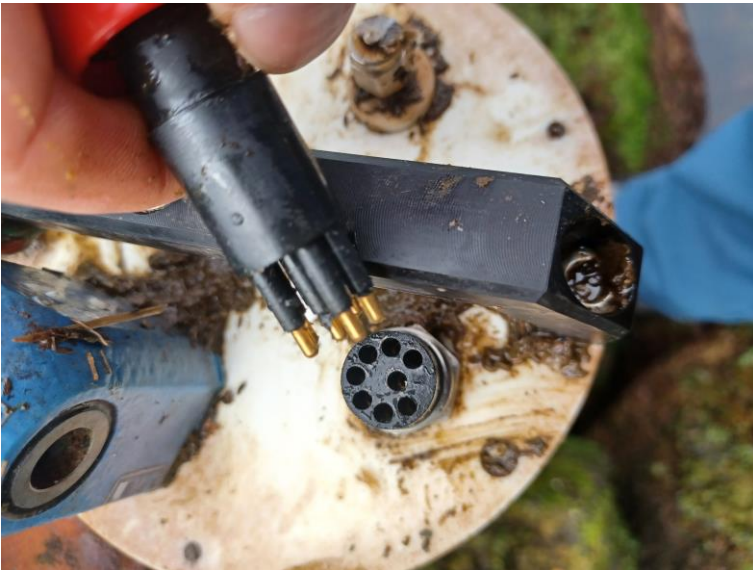
Lors de la déconnexion du câble de communication nous observons une forte humidité au niveau de la connectique

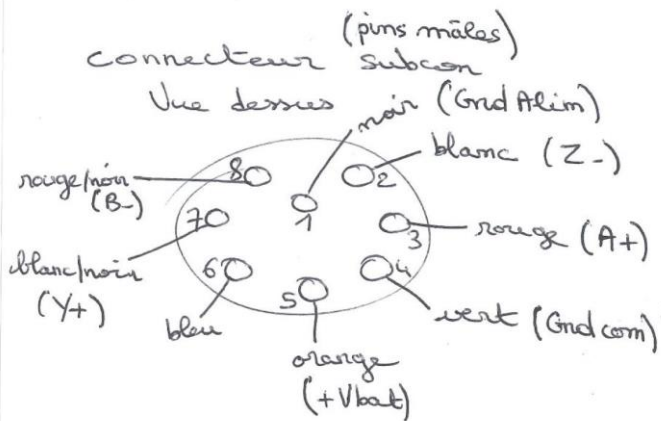
Test de la tension d'alimentation entre la borne 1 et 5 :

câblage
 ST Paul 1
 auxicom
 SD200-CT-P
 3x2x0,5 mm²
 (ancien câble)

Tension = 0V → pas de tension

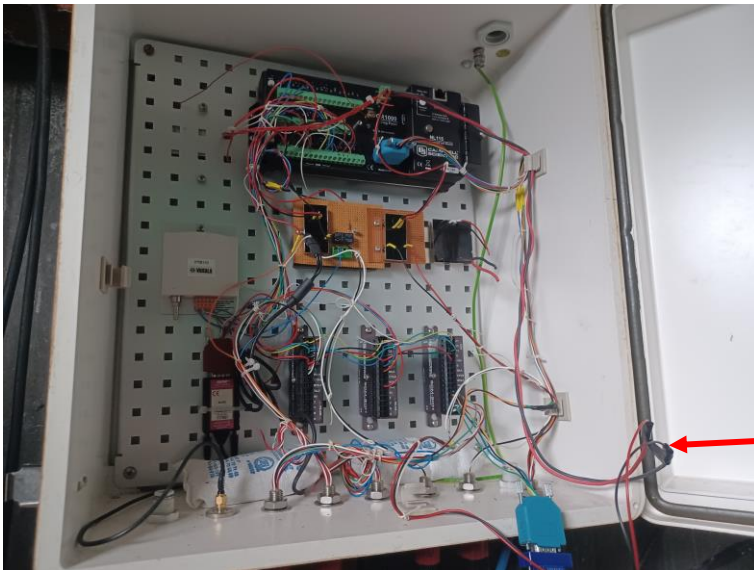
Nous remarquons que le coffret SP1 n'est pas alimenté

Câble d'alimentation du coffret :
 Tension mesurée 0V

La connexion de ce câble d'alimentation au niveau du coffret est un étamage avec du scotch pour l'isolation → Une utilisation de bornier type WAGO est à recommander, le risque de court-circuit est présent si mauvaise isolation avec le scotch

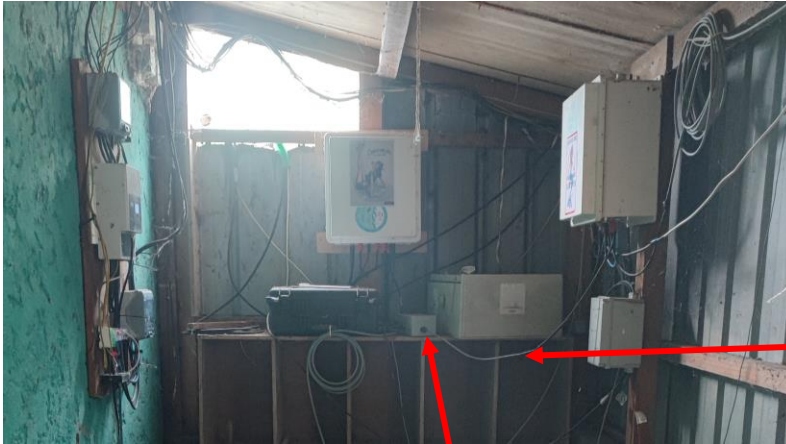
Câble d'alimentation vers le coffret SP1

Coffret d'alimentation de SP1

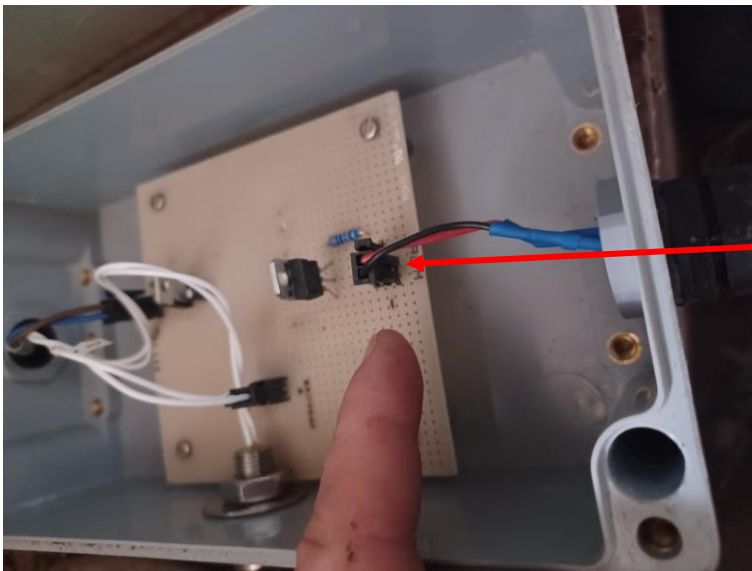
Bornier d'alimentation de SP1 :
Le bornier présente un faux contact coupant l'alimentation de SP1

Nous observons un faux contact au niveau du bornier permettant l'alimentation du coffret SP1. Nous avons réussi à réalimentation le coffret SP1 et bloquer le câble au niveau du presse étoupe.

NOTE : une fois l'alimentation remise, le radar filaire est réalimenté et refonctionne.

- Fiabiliser ce bornier pour éviter ce faux contact si le câble d'alimentation est touché.
- Un étiquetage des différents câbles permettrait une identification plus rapide pour les prochaines interventions.

- Le boîtier d'alimentation est à fiabiliser.
Un faux mouvement léger du câble peut bouger la connectique et donc couper SP1.
- Les différentes connexions de câbles étamés (beaucoup) devraient être reprise avec des systèmes de bornier type wago pour des questions de sécurisation du système et de fiabilisation.

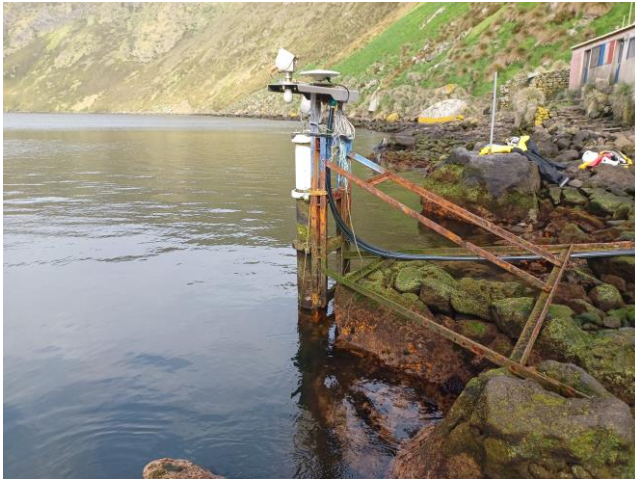
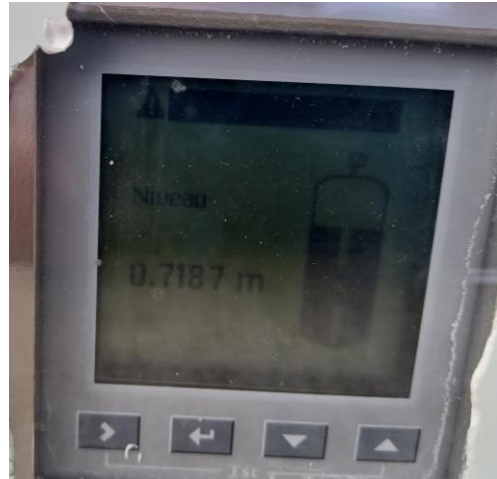
Heure : 01H41 UTC – 06h41 (heure Amsterdam) – Hauteur 0.7187m

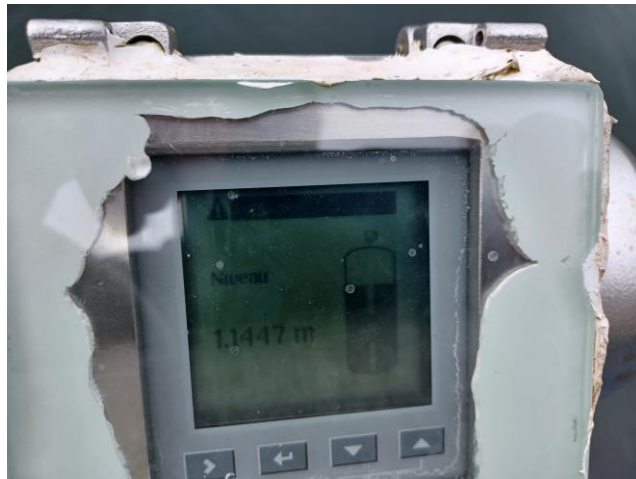
Heure 03h27 UTC – 08h27 (heure Amsterdam) Hauteur : 1.1447m
