Intervention Saint Paul

OP3-25 – Nivmer

Intervention le 17/11/2025 entre 06h14 et 09h25 (heure UTC+5)

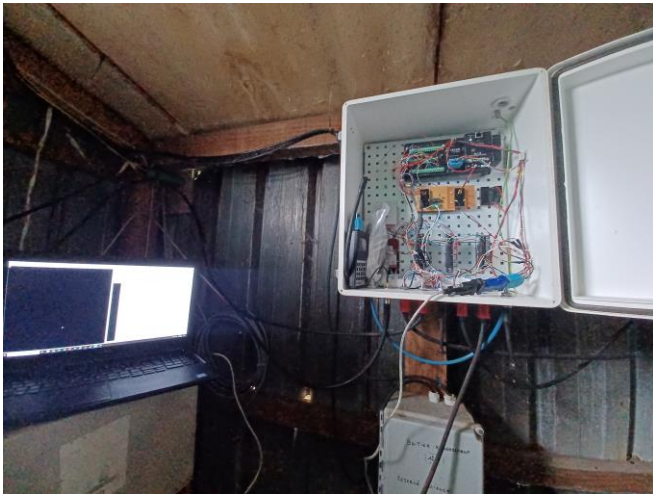
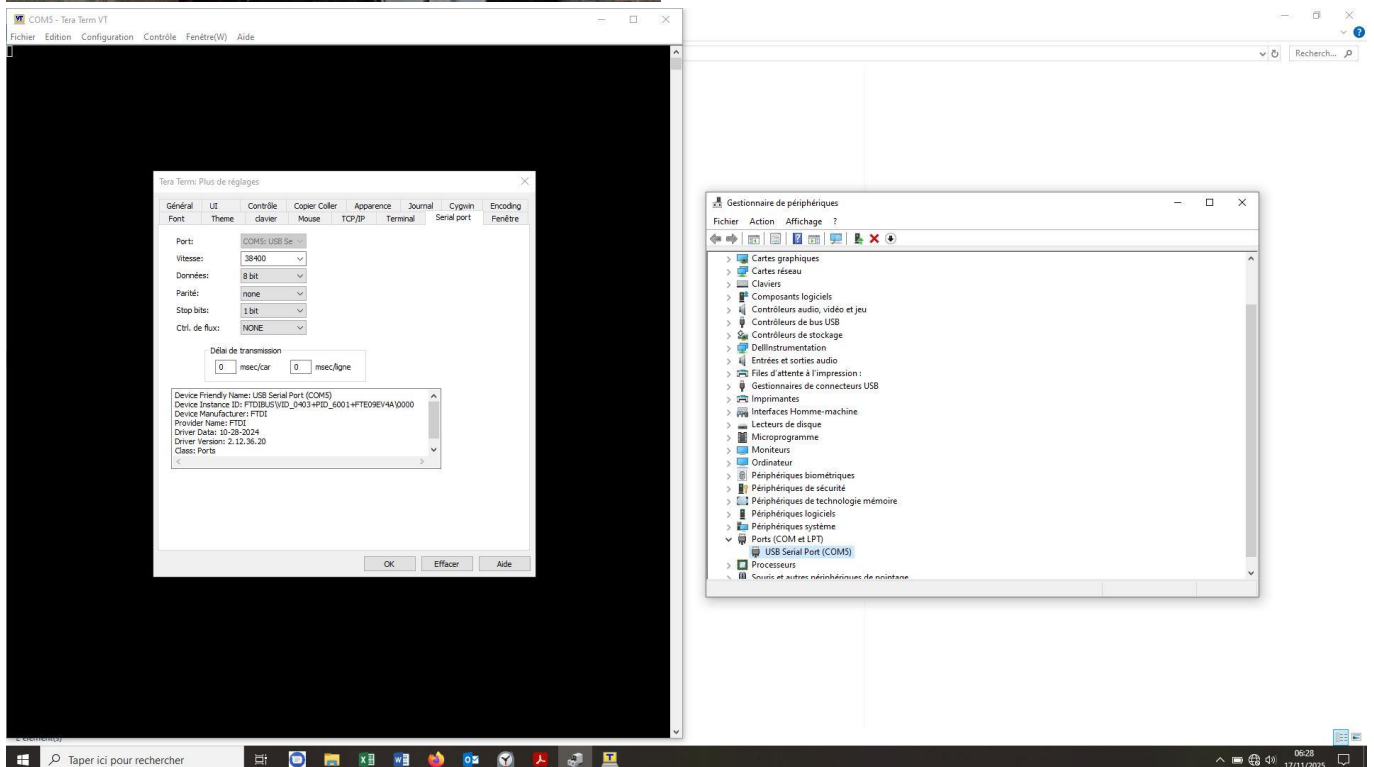
Connexion à la station SP1

Test de la communication :

Les tests en tapant sur entrée et les plusieurs ctrl+k → pas de réponse

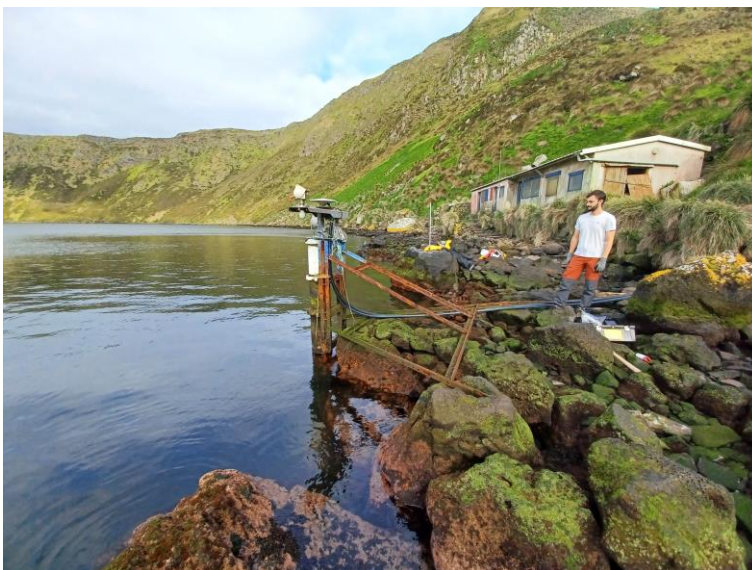
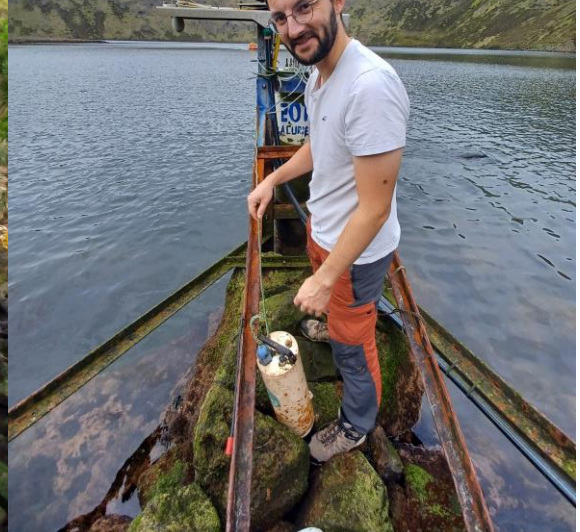
Pas de communication → Récupération du marégraphe à pression

NOTE : lors de la récupération du marégraphe, le radar filaire c'est éteint alors qu'il était alimenté avant et présentait des valeurs de niveau d'eau cohérente.

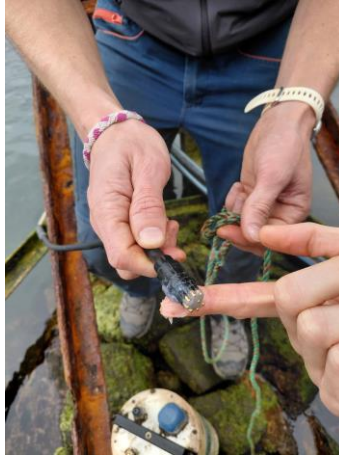
On observe bien des différences de valeurs → Fonctionnement cohérent.

Conclusion Marégraphe à pression de SP1 :

- Le marégraphe ne communiquait pas avant la coupure du coffret SP1 et communiquait après la réalimentation du coffret SP1.
Le marégraphe semble fonctionner après le malencontreux Shutdown de SP1 dû à la connectique du boîtier d'alimentation.
Est-ce que le fait d'éteindre et rallumer le coffret SP1 aurait résolu le problème ?

→ Graissage de la connectique et remise en place du marégraphe dans le tube blanc.

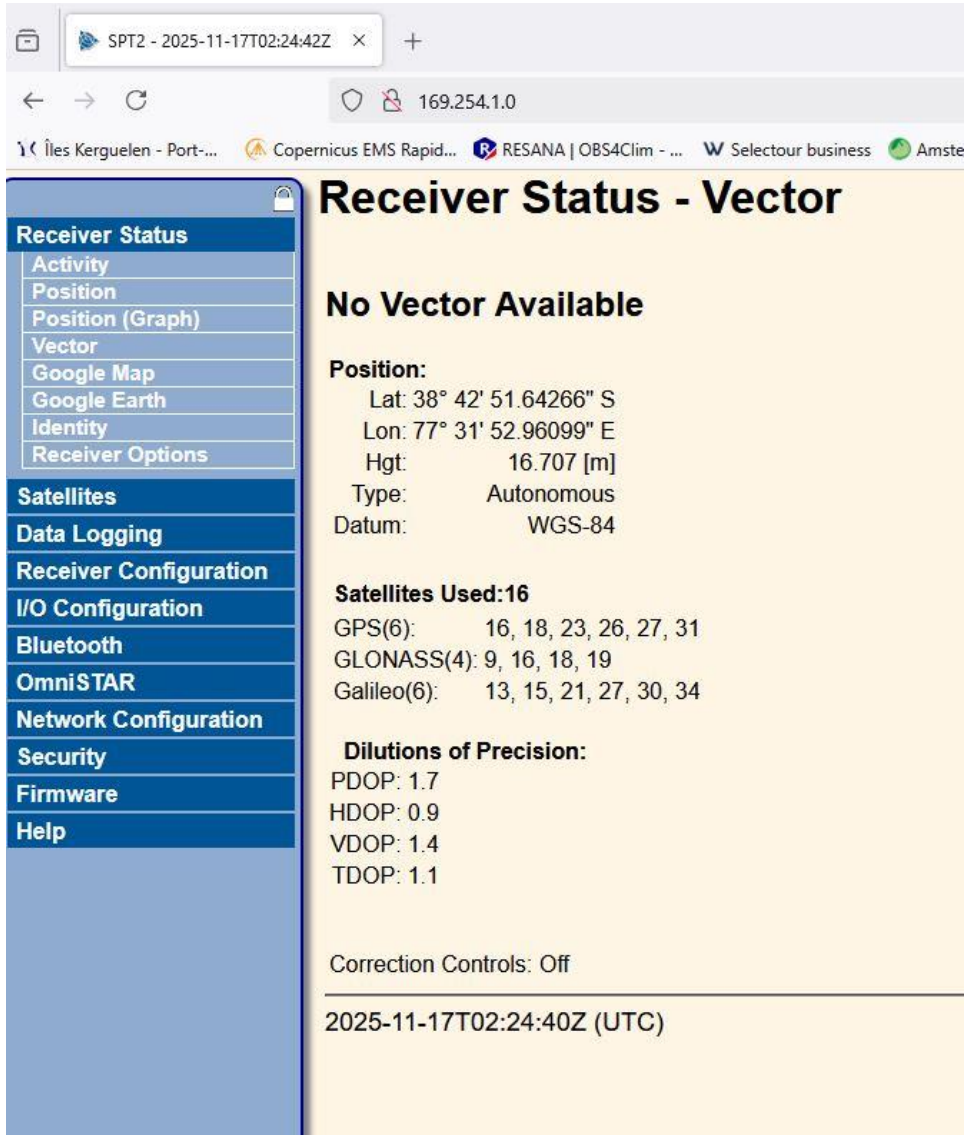
Vérification le fonctionnement du GPS SPT2 :

No Vector Available

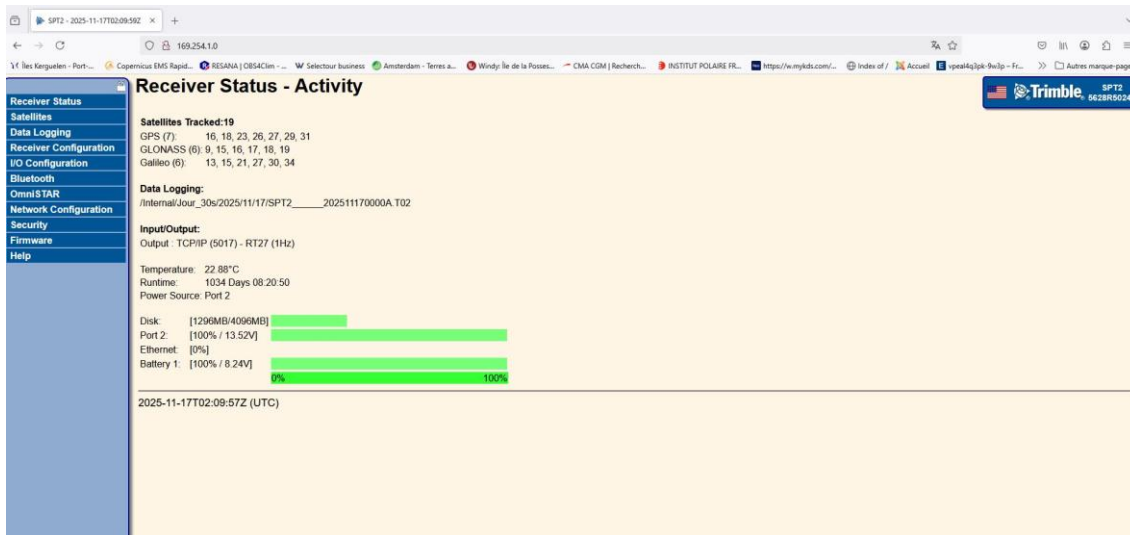
Receiver Status - Activity

Satellites Tracked: 19
 GPS (7) 16, 18, 23, 26, 27, 29, 31
 GLONASS (6) 9, 15, 16, 17, 18, 19
 Galileo (6) 13, 15, 21, 27, 30, 34
